Manhole Inspection Summary

Manhole # S17G__009MH

Insp Date: **1/22/09 1:27 PM**

Location Address: **59 CATHERINE-WARWICK**

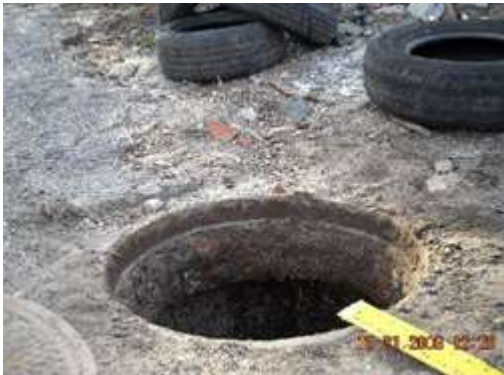
Location View

THERE IS A CAPPED STORM DRAIN CONNECTION AT THE 9 O'CLOCK OF THE SANITARY. THE PIPE IS NO

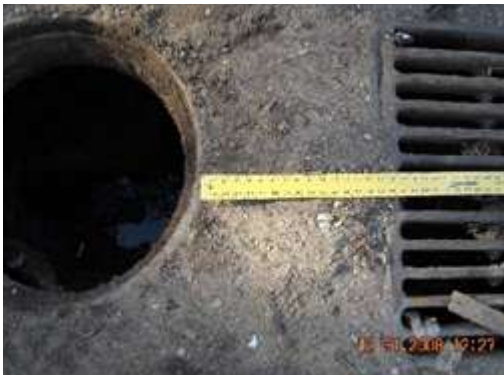
THERE IS A CAPPED STORM DRAIN CONNECTION AT THE 9 O'CLOCK OF THE SANITARY. THE PIPE IS NO

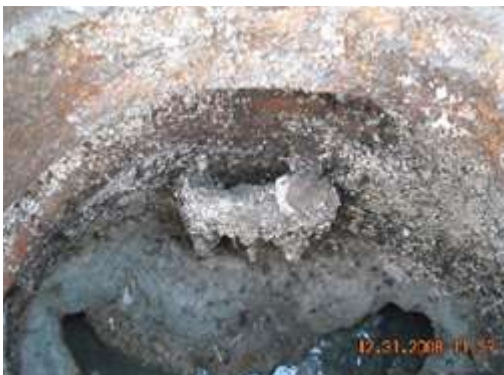
Defect 2

EVIDENCE OF HIGH PRIOR SURCHARGE ON STEP

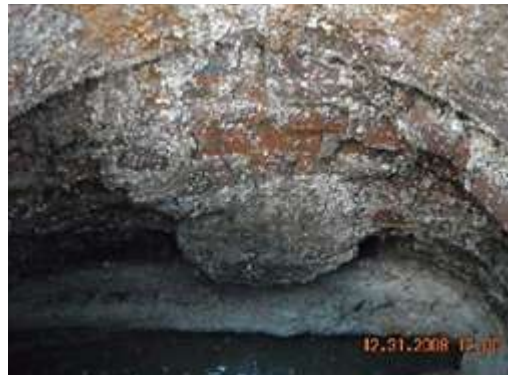
Defect 4

frame leaks

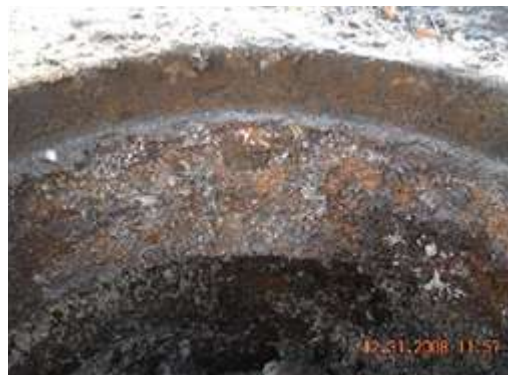
Defect 1

EVIDENCE OF INFLOW DUE TO SHEETING AND CORRODED MANHOLE FRAME

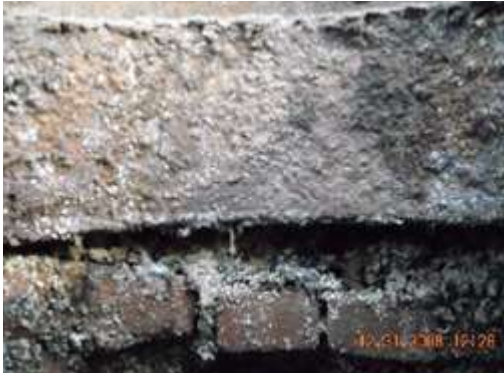
Defect 6

CHIMNEY IS MISSING AND DEGRADED

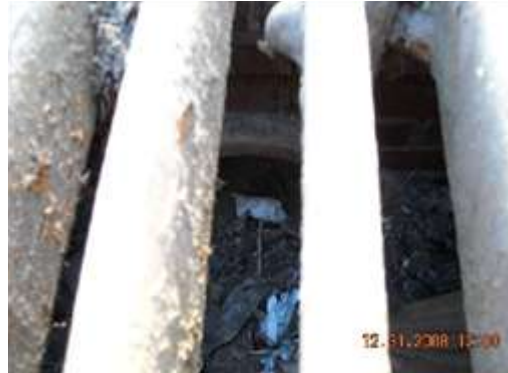
Defect 5

THIS IS THE STORM DRAIN
CONNECTION OPPOSITE OF THE
SANITARY 9 O'CLOCK IN. Debris on

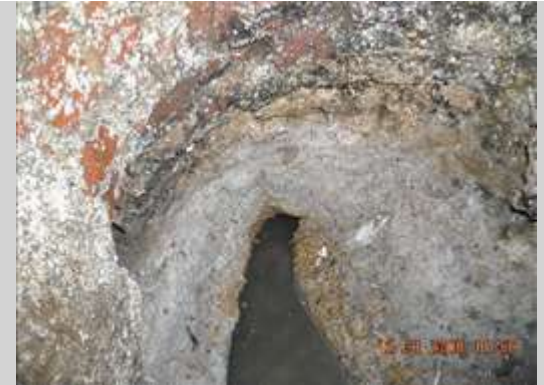
12 O'Clock Outflow

Deposits: ☐ None ☐ Mud ☒ **Sludge** ☐ Debris ☒ **Grease**

Silt Depth: **3** (in.) Deposits Extent: **Heavy**

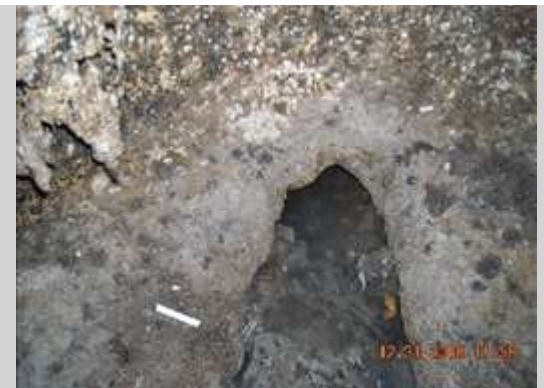
3 O'Clock Inflow

Deposits: ☐ None ☐ Mud ☒ **Sludge** ☐ Debris ☒ **Grease**

Silt Depth: **3** (in.) Deposits Extent: **Medium**

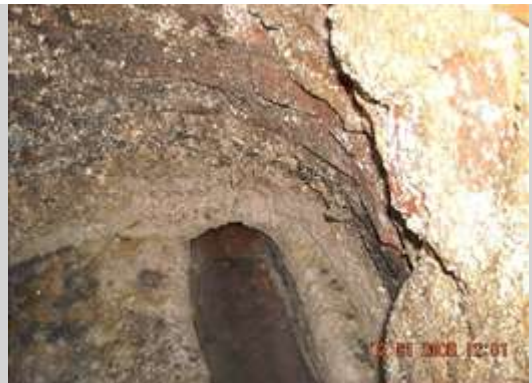
6 O'Clock Inflow

Deposits: ☐ None ☐ Mud ☒ **Sludge** ☐ Debris ☒ **Grease**

Silt Depth: **3** (in.) Deposits Extent: **Medium**
